Sensitive Watershed Nomination

Elk River Planning Watersheds

Humboldt County

Regional Water Quality Control Board

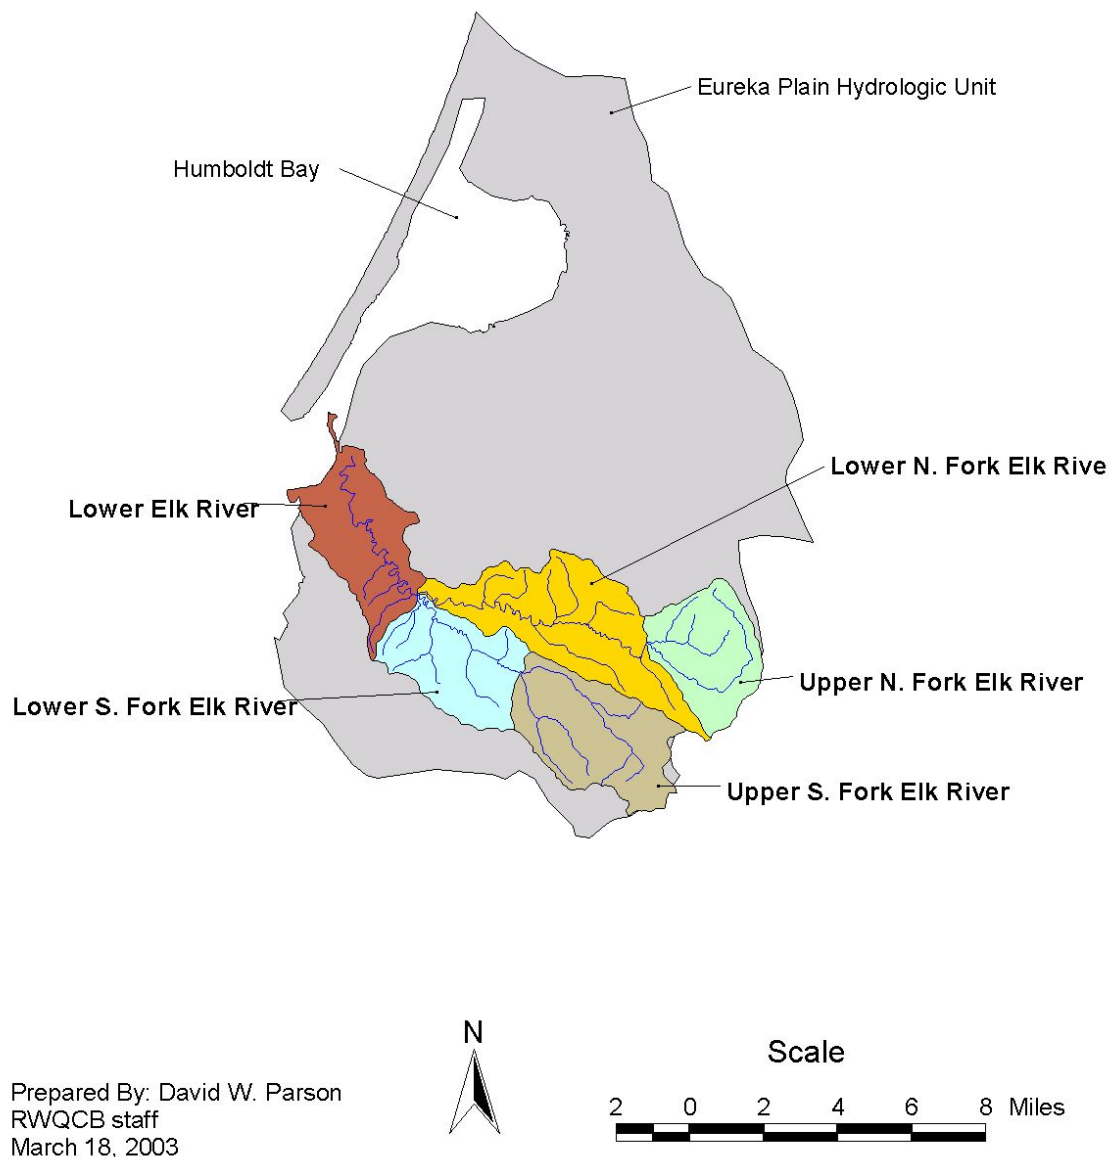
**Figure 1. Elk River Planning Watersheds
nominated for
Sensitive Watershed Designation**

The five Elk River planning watersheds are proposed for submittal to the Board of Forestry and Fire Protection (BOF) as a combined-package because of their spatial proximity, similar characteristics, level of adverse cumulative impacts and the continuing timber harvest activities. The grouping of the five planning watersheds is consistent with requirements of FPR section 916.8, which specifies that nominations need to be on a planning watershed scale. These five

sub-basins are based on the Calwater v2.2 planning watersheds. Calwater planning watersheds were developed by the California Department of Forestry and Fire Protection for use in timber harvest planning and review.
